Model(s)	Year	Eng. Code	Trans. Code	VIN Range From	VIN Range To
Passat	1998 - 2004	1.8L (AEB, ATW, AWM, AUG)	All	All	All

17 07 13 Aug. 17, 2007 **2013233** Supersedes T. B. Group 17 number 07 09 dated Apr. 11, 2007 due to procedural change of removing the second inspection of oil suction strainer and replacement of oil return line. **Engine Oil Pressure Too Low, Light is ON, Engine Flush**

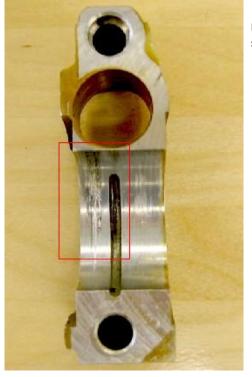
- Place the vehicle in "service position".
- Remove cylinder head cover.
- · Remove plastic oil deflectors from the top of intake camshaft.
- Inspect all camshaft bearings (remove only one cap at a time) for damage.

If one or more camshaft bearings are damaged, the complete engine must be replaced as described in **"Engine Replacement Guidelines"** section.

If ALL camshaft bearings are OK (NOT damaged), the engine must be repaired as described in "Engine Repair Guidelines" section.
